**Flood Control Project Maintenance  
Levee Inspections**  
**LMA District Cover Sheet**  
**Spring 2018 Levee Inspection Results**

**Reclamation District No. 0404 Boggs**

**Spring 2018 Levee Inspection Results**

**Levee Inspection Report By Mile - Spring 2018**

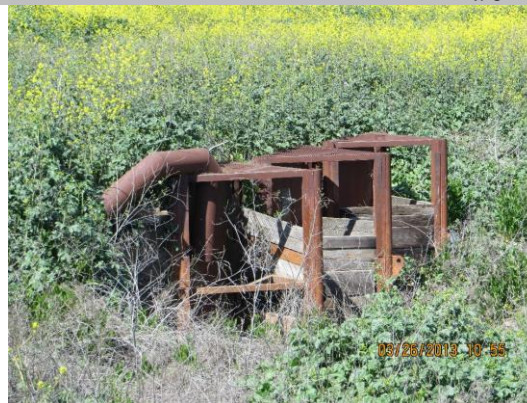
Photo 1 of 3 : UCIP\_SP\_2018\_51168\_20041.jpg

LM Start	0.65	Rating **	M	Issue No.	104
LM End	0.65	Issue Type +	En	Location *	
Category	Supplemental			GPS Latitude/Longitude	
				Start	End
Item	DWR UCIP Field Study			37.938670 °	37.938670 °
				-121.335397 °	-121.335397 °
DWR ID					
Comment Code					
Inspector Comment					
FS_ID:51168 DS_ID:17952 EP_NO: N/A Repair Type: Non-Urgent Crossing Status: Found UCIP Comments: Steel intake structure on landside of the levee. FIELD_STRUCT_DESC: 1 of 3: 30-inch corrugated metal gravity drainage pipe through the levee, 22 feet below the crown. Flap gate on the waterside (WS) end. Steel intake structure on the landside (LS). [Additional Reference(s): DWR Levee Log, 2006]. FS Date: 3/26/2013

LS- intake structure

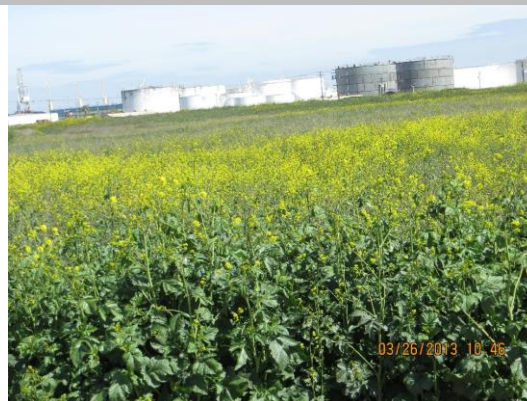
Photo 2 of 3 : UCIP\_SP\_2018\_51168\_20040.jpg

LS- overview of land side of the levee.

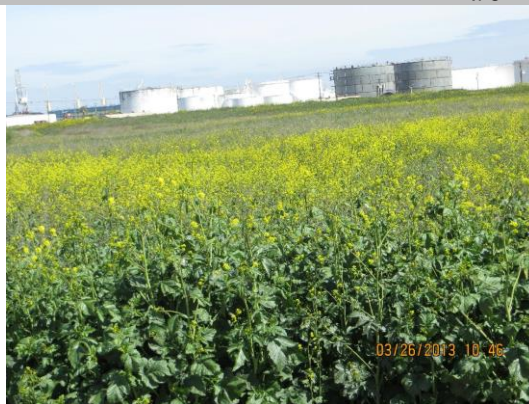
Photo 3 of 3 : UCIP\_SP\_2018\_51166\_20048.jpg

Comment Code						
Inspector Comment						
FS_ID:51166 DS_ID:18811 EP_NO: N/A Repair Type: Urgent Crossing Status: Found UCIP Comments: 12/13/2016 Since previous inspector and 2006 Levee Log cite damage to flap gate, I have upgraded this crossing from Non-Urgent to Urgent. Flap gates need to be in good working condition. (K. Fazel - UCIP)03/26/2013 Steel intake structure on LS. (P. Amatya - DWR)12/26/2006 Landward end filled with dirt. Middle flap gate missing and right flap gate broken as of 1/24/07. (DWR Levee Log) FIELD_STRUCT_DESC: 2 of 3: 30-inch corrugated metal gravity drainage pipe through the levee, 22 feet below the crown. Flap gate on the waterside (WS) end. Steel intake structure on the landside (LS). [Additional Reference(s): DWR Levee Log, 2006]. FS Date: 3/26/2013

LS- overview of landside of the levee

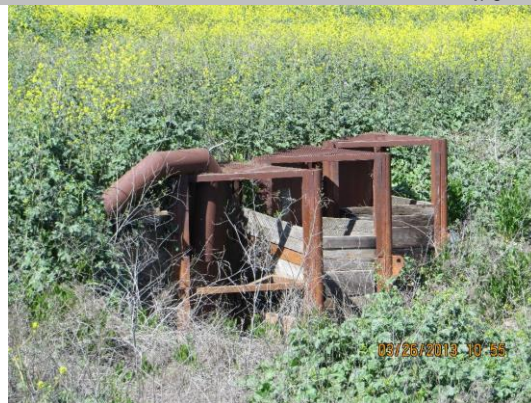
Photo 1 of 3 : UCIP\_SP\_2018\_51167\_20054.jpg

Comment Code					
Inspector Comment					
FS_ID:51167 DS_ID:18810 EP_NO: N/A Repair Type: Urgent Crossing Status: Found UCIP Comments: 12/13/2016 Since previous inspector and 2006 Levee Log cite damage to flap gate, I have upgraded this crossing from Non-Urgent to Urgent. Flap gates need to be in good working condition. (K. Fazel - UCIP)03/26/2013 Steel intake structure on LS. (P. Amatya - DWR)12/26/2006 Landward end filled with dirt. Middle flap gate missing and right flap gate broken as of 1/24/07. (DWR Levee Log) FIELD_STRUCT_DESC: 3 of 3: 30-inch corrugated metal gravity drainage pipe through the levee, 22 feet below the crown. Flap gate on the waterside (WS) end. Steel intake structure on the landside (LS). [Additional Reference(s): DWR Levee Log, 2006]. FS Date: 3/26/2013

LS- steel intake structure

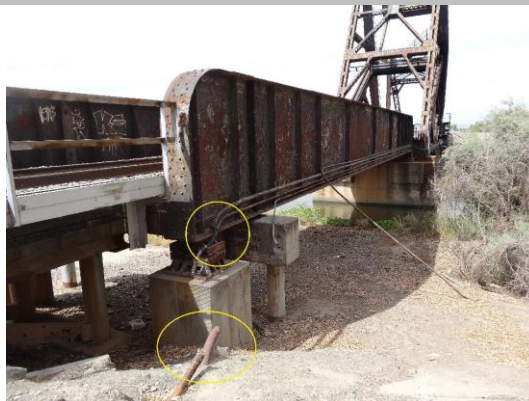
Photo 2 of 3 : UCIP\_SP\_2018\_46810\_74754.jpg

LM Start	0.79	Rating **	M	Issue No.	108	
LM End	0.79	Issue Type +	En	Location *		
Category	Supplemental			GPS Latitude/Longitude		
				Start	End	
Item	DWR UCIP Field Study			37.937212 °	37.937212 °	
				-121.333762 °	-121.333762 °	
DWR ID						
Comment Code						
Inspector Comment						
FS_ID:46810						
DS_ID:17946						
EP_NO: N/A						
Repair Type: Non-Urgent						
Crossing Status: Found						
UCIP Comments: Appears abandoned; if so should be done so properly.						
FIELD_STRUCT_DESC: Telephone conduit of an unknown size or						
material through both levees and under the San Joaquin River, at an						
unknown depth. This buried telephone cable is no longer operational.						
[Additional Reference(s): DWR Levee Log, 2006].						
FS Date: 8/4/2015

WS view looking west: conduits thru levee and attached to bridge

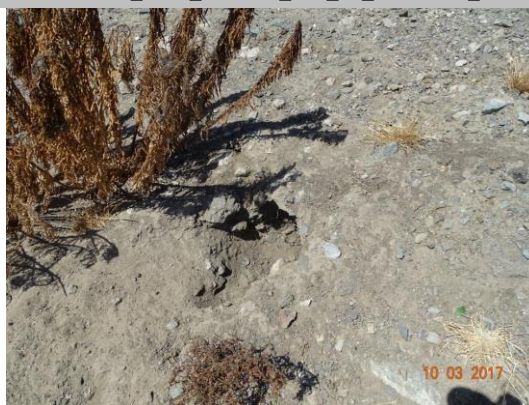
Photo 1 of 2 : SP\_2018\_RD0404\_305\_42\_20180323\_00018.jpg

LM Start	0.98	Rating **	U	Issue No.	42
LM End	0.98	Issue Type +	Ma	Location *	WS
Category	Earthen Levee			GPS Latitude/Longitude	
				Start	End
Item	Animal Control			37.935918 °	37.935918 °
				-121.331032 °	-121.331032 °
DWR ID	DWR_RD0404_01_s_2017_42				
Comment Code					
A3 : No rodents visible, but rodent burrows visible; need to backfill and compact or grout burrows.					
Inspector Comment

View of the waterside slope looking southwest.

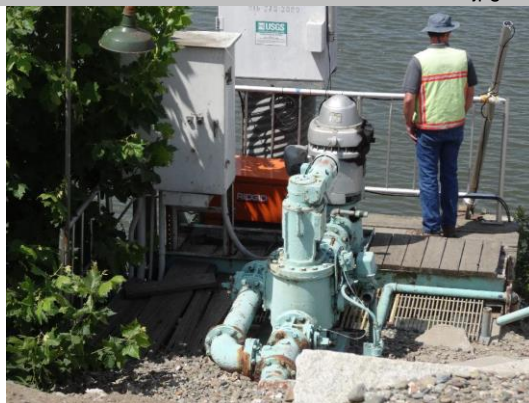
Photo 3 of 3 : UCIP\_SP\_2018\_46801\_74748.jpg

Comment Code						
Inspector Comment						
FS_ID:46801 DS_ID:25128 EP_NO: 1164 Repair Type: Non-Urgent Crossing Status: Indicator Found UCIP Comments: Conversation with WWTP engineer Ali Gharegozloo suggested this pipe has been welded shut. If so, mode of abandonment needs verification. FIELD_STRUCT_DESC: 60-inch lock joint reinforced concrete sewage effluent pipe under the levee, 27 feet below the crown. Reinforced concrete apron and cutoff walls. Steel sheet piling apron installed with the pipe on the waterside (WS) slope. Headwall, stairs, and pump with shutoff valve visible on the WS slope. Apparent shutoff valves 30 feet off the landside (LS) toe in alignment with the pipe. (Plans for the construction of a 60-inch lock joint reinforced concrete sewage effluent pipe under the easterly levee of the San Joaquin River authorized under Permit No. 1164, 1947 - City of Stockton). FS Date: 7/9/2015

WS view: closeup of pump. CMP riser for USGS gage behind pump.

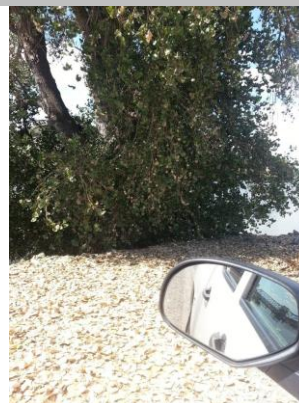
Photo 1 of 1 : SP\_2018\_RD0404\_305\_27\_20180323\_00013.jpg

LM Start	1.50	Rating **	A/W	Issue No.	27
LM End	1.50	Issue Type +	Ma	Location *	WS
Category	Earthen Levee			GPS Latitude/Longitude	
				Start	End
Item	Trim / Thin Trees			37.896544 °	37.896544 °
				-121.327121 °	-121.327121 °
DWR ID	DWR_RD0404_01_f_2016_27				
Comment Code					
T2 : Thin trees to allow visibility of the ground and room to flood fight.					
Inspector Comment

Looking west at untrimmed trees on waterward slope.

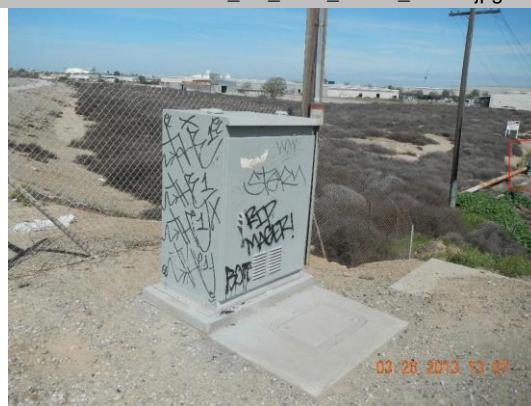
Photo 1 of 3 : UCIP\_SP\_2018\_50763\_20104.jpg

Comment Code					
Inspector Comment					
FS_ID:50763 DS_ID:18708 EP_NO: 4175 Repair Type: Non-Urgent Crossing Status: Found UCIP Comments: 11/17/2016 FPIIB Inspector Richard Willoughby noted 3-4 inch depression over pipes on crown, an indication of possible pipe collapse. (K. Fazel - UCIP) FIELD_STRUCT_DESC: 1 of 2: 12-inch steel drainage discharge pipe through the levee, 5 feet below the crown. Siphon breaker on the waterside (WS) shoulder. Power pole, electrical control panel, and pump about 200 feet off the landside (LS) toe. (Plans for installation of a 10-inch, 12-gauge welded steel discharge pipe over the levee authorized under Permit No. 4175, 1963 - City of Stockton). [Additional Reference(s): DWR Levee Log, 2006]. FS Date: 11/17/2016

LS- overview of pipe and pump (far right)

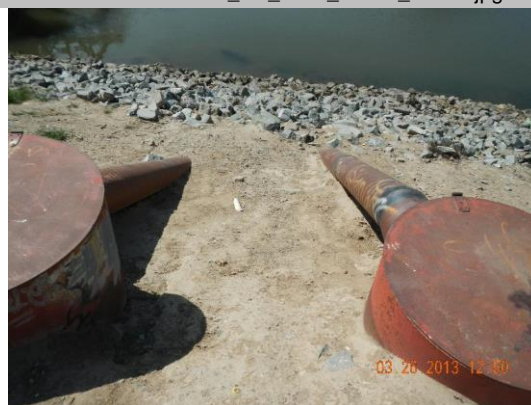
Photo 2 of 3 : UCIP\_SP\_2018\_50763\_20103.jpg

WS- steel pipes and siphon breakers in steel pipe risers.

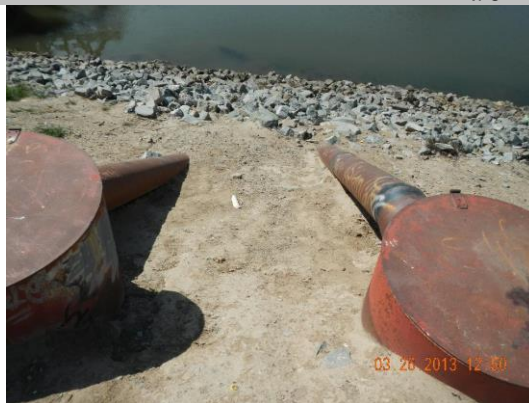
Photo 1 of 3 : UCIP\_SP\_2018\_50764\_19994.jpg

Comment Code						
Inspector Comment						
FS_ID:50764 DS_ID:17955 EP_NO: 4175 Repair Type: Non-Urgent Crossing Status: Found UCIP Comments: 11/17/2016 FPIIB Inspector Richard Willoughby noted 3-4 inch dip in crown over pipes, an indication of possible pipe collapse. (K. Fazel - UCIP) FIELD_STRUCT_DESC: 2 of 2: 12-inch steel drainage discharge pipe through the levee, 5 feet below the crown. Siphon breaker on the waterside (WS) shoulder. Power pole, electrical control panel, and pump about 200 feet off the landside (LS) toe. (Plans for installation of a 10-inch, 12-gauge welded steel discharge pipe over the levee authorized under Permit No. 4175, 1963 - City of Stockton). [Additional Reference(s): DWR Levee Log, 2006, 10-inch pipe referenced]. FS Date: 11/17/2016

WS- steel pipes and siphon breakers in steel pipe risers.

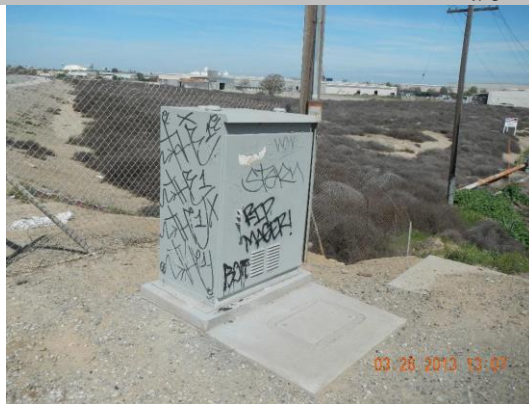
Photo 2 of 3 : UCIP\_SP\_2018\_50764\_19996.jpg

LS- pipe and pump on far left.

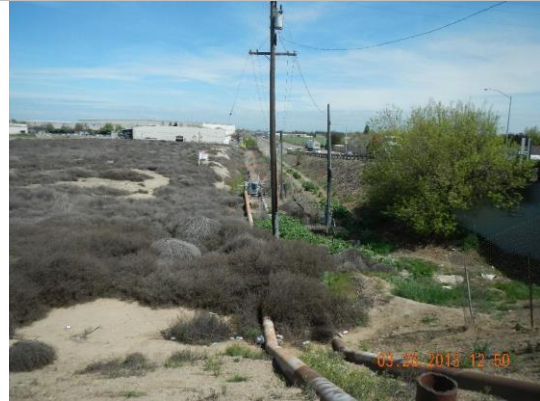
Photo 3 of 3 : UCIP\_SP\_2018\_50764\_19995.jpg

Comment Code						
Inspector Comment						
FS_ID:50764 DS_ID:17955 EP_NO: 4175 Repair Type: Non-Urgent Crossing Status: Found UCIP Comments: 11/17/2016 FPIIB Inspector Richard Willoughby noted 3-4 inch dip in crown over pipes, an indication of possible pipe collapse. (K. Fazel - UCIP) FIELD_STRUCT_DESC: 2 of 2: 12-inch steel drainage discharge pipe through the levee, 5 feet below the crown. Siphon breaker on the waterside (WS) shoulder. Power pole, electrical control panel, and pump about 200 feet off the landside (LS) toe. (Plans for installation of a 10-inch, 12-gauge welded steel discharge pipe over the levee authorized under Permit No. 4175, 1963 - City of Stockton). [Additional Reference(s): DWR Levee Log, 2006, 10-inch pipe referenced]. FS Date: 11/17/2016

LS- pipes and pumps on center.

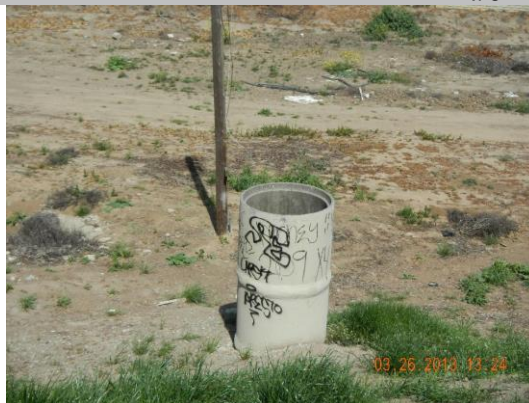
Photo 2 of 3 : UCIP\_SP\_2018\_40487\_20063.jpg

Comment Code						
Inspector Comment						
FS_ID:40487						
DS_ID:18812						
EP_NO: 10897						
Repair Type: Non-Urgent						
Crossing Status: Found						
UCIP Comments: Abandoned crossing. WS pipe capped with steel pipe and LS pipe cut.						
FIELD_STRUCT_DESC: *ABANDONED* 14-inch irrigation discharge pipe of an unknown material through the levee, 3 feet below the crown. Siphon breaker on the waterside (WS). (Plans to install a 20-horsepower irrigation pump on an existing structure and a 14-inch discharge pipe through the levee authorized under Permit No. 10897, 1975 - Alfred Volpi. 14-inch pipe replaces existing 12-inch pipe).						
[Additional Reference(s): DWR Levee Log, 2006. USACE San Joaquin O&M Manual 1, March 1963, (HLM 1.63), 12-inch pipe referenced, 5.5 feet below the crown].						
FS Date: 3/26/2013

LS- concrete standpipe on levee slope

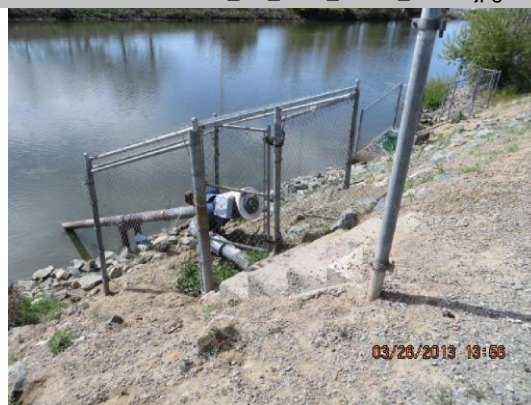
Photo 1 of 3 : UCIP\_SP\_2018\_40797\_20073.jpg

LM Start	1.81	Rating **	M	Issue No.	114
LM End	1.81	Issue Type +	En	Location *	
Category	Supplemental			GPS Latitude/Longitude	
				Start	End
Item	DWR UCIP Field Study			37.926168 °	37.926168 °
				-121.324514 °	-121.324514 °
DWR ID					
Comment Code					
Inspector Comment					
FS_ID:40797 DS_ID:17961 EP_NO: 6560 Repair Type: Non-Urgent Crossing Status: Found UCIP Comments: Damaged siphon breaker in pipe riser near the landward shoulder. FIELD_STRUCT_DESC: 8-inch steel irrigation discharge pipe through the levee, 7 feet below the crown. Chain-link fence around the pump and motor on the waterside (WS) slope. (Plans to install a 7-horsepower pump and motor, cyclone fence, and an 8-inch steel pipe through the levee authorized under Permit No. 6560, 1969 - City of Stockton, Department of Public Works). [Additional Reference(s): DWR Levee Log, 2006]. FS Date: 3/26/2013

WS- slanted pump, pipe, and concrete steps on levee slope.

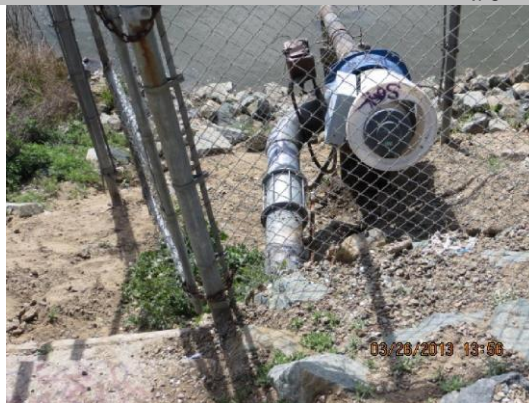
Photo 2 of 3 : UCIP\_SP\_2018\_40797\_20072.jpg

LM Start	1.81	Rating **	M	Issue No.	114 (cont)	
LM End	1.81	Issue Type +	En	Location *		
Category	Supplemental			GPS Latitude/Longitude		
				Start		End
Item	DWR UCIP Field Study			37.926168 °		37.926168 °
				-121.324514 °		-121.324514 °
DWR ID						
Comment Code						
Inspector Comment						
FS_ID:40797 DS_ID:17961 EP_NO: 6560 Repair Type: Non-Urgent Crossing Status: Found UCIP Comments: Damaged siphon breaker in pipe riser near the landward shoulder. FIELD_STRUCT_DESC: 8-inch steel irrigation discharge pipe through the levee, 7 feet below the crown. Chain-link fence around the pump and motor on the waterside (WS) slope. (Plans to install a 7-horsepower pump and motor, cyclone fence, and an 8-inch steel pipe through the levee authorized under Permit No. 6560, 1969 - City of Stockton, Department of Public Works). [Additional Reference(s): DWR Levee Log, 2006]. FS Date: 3/26/2013

WS- slanted pump, and pipe on levee slope.

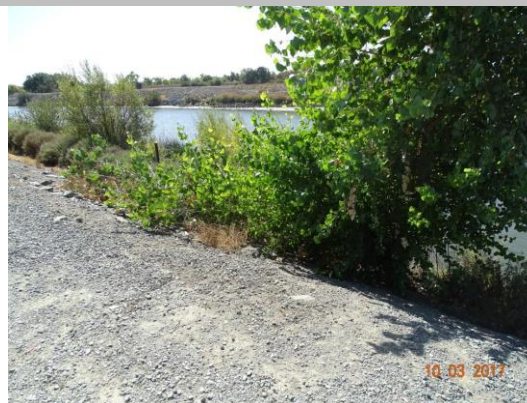
Photo 1 of 1 : SP\_2018\_RD0404\_305\_22\_20180323\_00011.jpg

LM Start	2.14	Rating **	A/W	Issue No.	22
LM End	2.14	Issue Type +	Ma	Location *	WS
Category	Earthen Levee			GPS Latitude/Longitude	
				Start	End
Item	Trim / Thin Trees			37.922040 °	37.922040 °
				-121.321446 °	-121.321446 °
DWR ID	DWR_RD0404_01_f_2017_22				
Comment Code					
T1 : Trim trees to at least five feet above ground level.					
Inspector Comment

View of the waterside slope looking south.

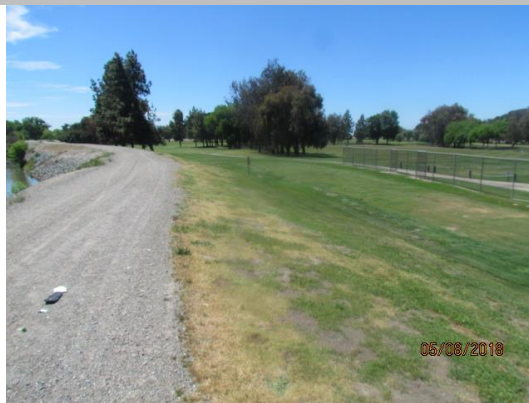
Photo 1 of 1 : SP\_2018\_RD0404\_306\_9\_20180511\_00027.jpg

LM Start	0.00	Rating **	A	Issue No.	9
LM End	1.73	Issue Type +	Ma	Location *	LS
Category	Earthen Levee			GPS Latitude/Longitude	
				Start	End
Item	Vegetation			37.920324 °	37.917414 °
				-121.318348 °	-121.292170 °
DWR ID	DWR_RD0404_02_s_2018_9				
Comment Code					
V1 : Control annual grass and weeds on the levee slopes and easements.					
Inspector Comment					
District is maintaining annual grasses and weeds.

Looking downstream at typical view of landward slope. (Spring 2018)

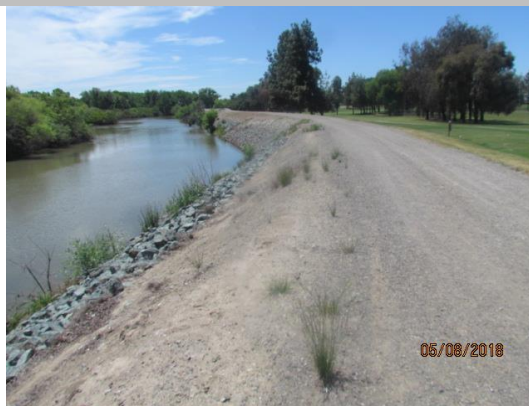
Photo 1 of 1 : SP\_2018\_RD0404\_306\_10\_20180511\_00026.jpg

LM Start	0.00	Rating **	A	Issue No.	10
LM End	1.73	Issue Type +	Ma	Location *	WS
Category	Earthen Levee			GPS Latitude/Longitude	
				Start	End
Item	Vegetation			37.920324 °	37.917410 °
				-121.318348 °	-121.292167 °
DWR ID	DWR_RD0404_02_s_2018_10				
Comment Code					
V1 : Control annual grass and weeds on the levee slopes and easements.					
Inspector Comment					
District is maintaining annual grasses and weeds.

Looking downstream at typical view of waterward slope. (Spring 2018)

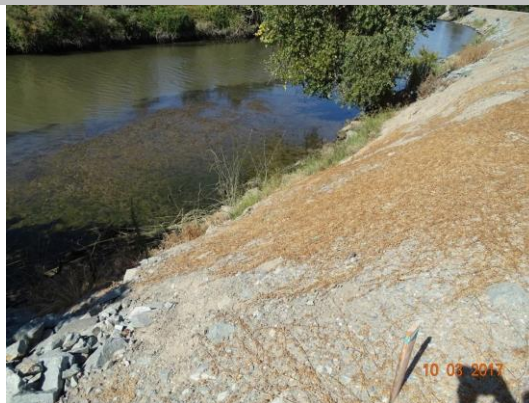
Photo 1 of 2 : SP\_2018\_RD0404\_306\_14\_20180323\_00003.jpg

LM Start	0.14	Rating **	U	Issue No.	14
LM End	0.14	Issue Type +	Ma	Location *	WS
Category	Earthen Levee			GPS Latitude/Longitude	
				Start	End
Item	Erosion / Bank Caving			37.918875 °	37.918875 °
				-121.316587 °	-121.316587 °
DWR ID	DWR_RD0404_02_f_2017_14				
Comment Code					
E2 : Schedule repair of erosion site prior to the next inspection.					
Inspector Comment					
Erosion occurred winter 2017.

View of the waterside slope looking northwest.

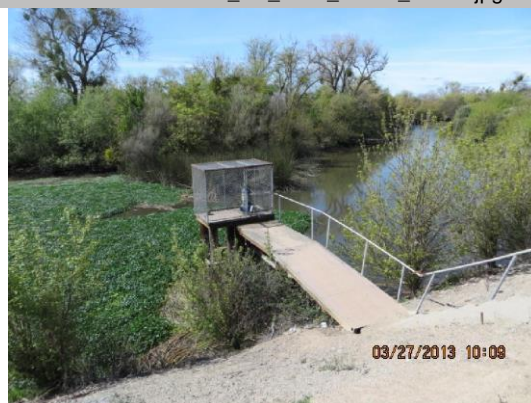
Photo 1 of 3 : UCIP\_SP\_2018\_10908\_18182.jpg

Comment Code					
Inspector Comment					
FS_ID:10908 DS_ID:18781 EP_NO: 3340A Repair Type: Non-Urgent Crossing Status: Found UCIP Comments: - Not working for 5 years- Golf club staff- Wooden Walkway; Concrete steps- Damaged siphon breaker FIELD_STRUCT_DESC: 6-inch steel irrigation discharge pipe through the levee, 2 feet below the crown. One corrugated metal cutoff wall. Pump on a pile structure in the stream. Shutoff valve and siphon breaker on the waterside (WS) shoulder. Timber walkway on the WS slope. (Plans for installation of three pumping plants on the north levee of French Camp Slough authorized under Permit No. 3340-A, 1960 - City of Stockton). [Additional Reference(s): DWR Levee Log, 2006]. FS Date: 3/27/2013

WS- pump on steel structure and wooden walkway

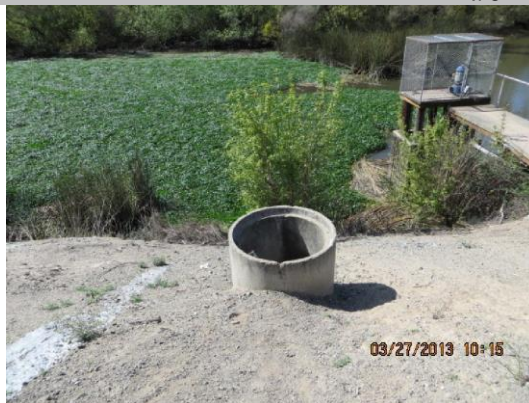
Photo 2 of 3 : UCIP\_SP\_2018\_10945\_18247.jpg

Comment Code						
Inspector Comment						
FS_ID:10945 DS_ID:18782 EP_NO: 4448 Repair Type: Non-Urgent Crossing Status: Found UCIP Comments: Concrete stairway on waterward slope- Not found. Pump was working during field survey. Siphon breaker cap missing. FIELD_STRUCT_DESC: 18-inch steel drainage discharge pipe through the levee, 9.3 feet below the crown. Pump on the landside (LS). Two corrugated metal cutoff walls. Siphon breaker in a concrete well on the waterside (WS) shoulder. (Plans for installation of a discharge pipe through the levee authorized under Permit No. 4448, 1964 - City of Stockton, Department of Public Works). [Additional Reference(s): DWR Levee Log, 2006]. FS Date: 3/27/2013

WS- concrete riser on steep levee slope

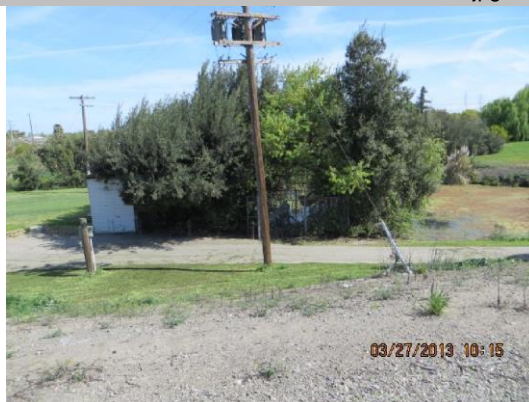
Photo 3 of 3 : UCIP\_SP\_2018\_10945\_18250.jpg

LS- overview of pumping plant and levee slope

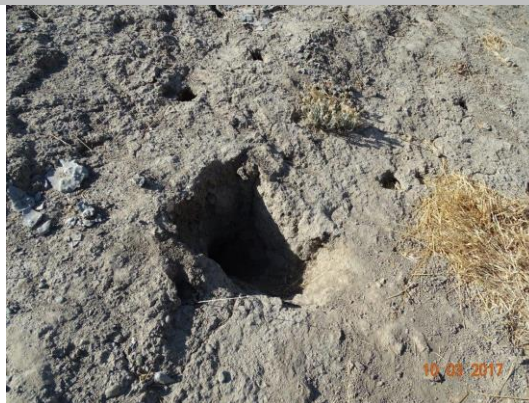
Photo 1 of 4 : SP\_2018\_RD0404\_306\_20\_20180323\_00005.jpg

LM Start	1.03	Rating **	U	Issue No.	20	
LM End	1.08	Issue Type +	Ma	Location *	LS	
Category	Earthen Levee			GPS Latitude/Longitude		
				Start		End
Item	Animal Control			37.916302 °		37.916383 °
				-121.303690 °		-121.302802 °
DWR ID	DWR_RD0404_02_s_2016_20					
Comment Code						
A3 : No rodents visible, but rodent burrows visible; need to backfill and compact or grout burrows.						
Inspector Comment						
Large rodent holes on landward slope and levee crown.

View of the landside slope looking north.

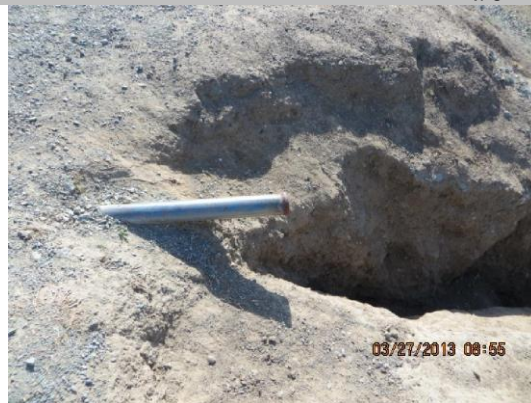
Photo 1 of 3 : UCIP\_SP\_2018\_51171\_18134.jpg

Comment Code					
Inspector Comment					
FS_ID:51171 DS_ID:18792 EP_NO: 3340 Repair Type: Non-Urgent Crossing Status: Indicator Found UCIP Comments: 11/29/2016 Pipe was not found. As per DWR Inspector Richard Willoughby, pipe was removed by City without a permit. Erosion cited previously has been backfilled. Backfill material on WS is redder in color than original material, indicating a recent backfill. Crossing has been downgraded from Urgent to Non-Urgent since no permit issued for this work. (K. Fazel - UCIP)03/27/2013 Abandoned and capped 3-in GI pipe found on WS. Damaged air-valve/siphon breaker found on LS. Gully formed due to leaky pipe. A pump house found on LS but it needs to be verified by LMA whether this is associated with this crossing. (P. Amatya - DWR) FIELD_STRUCT_DESC: *REMOVED* 3-inch galvanized iron irrigation discharge pipe through the levee, 1 foot below the crown. Pile structure in the stream. Damaged siphon breaker at the landside (LS) toe. (Plans for installation of three pumping plants on the north levee of French Camp Slough authorized under Permit No. 3340-A, 1960 - City of Stockton). FS Date: 11/29/2016

WS- capped 3-inch GI pipe

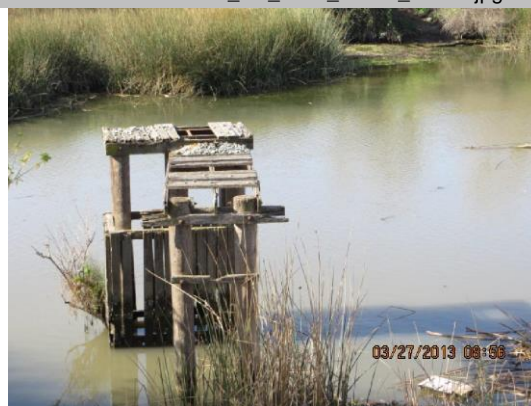
Photo 3 of 3 : UCIP\_SP\_2018\_51171\_18132.jpg

FS\_ID:51171  
 DS\_ID:18792  
 EP\_NO: 3340  
 Repair Type: Non-Urgent  
 Crossing Status: Indicator Found  
 UCIP Comments: 11/29/2016 Pipe was not found. As per DWR Inspector Richard Willoughby, pipe was removed by City without a permit. Erosion cited previously has been backfilled. Backfill material on WS is redder in color than original material, indicating a recent backfill. Crossing has been downgraded from Urgent to Non-Urgent since no permit issued for this work. (K. Fazel - UCIP)03/27/2013 Abandoned and capped 3-in GI pipe found on WS. Damaged air-valve/siphon breaker found on LS. Gully formed due to leaky pipe. A pump house found on LS but it needs to be verified by LMA whether this is associated with this crossing. (P. Amatya - DWR)  
 FIELD\_STRUCT\_DESC: \*REMOVED\* 3-inch galvanized iron irrigation discharge pipe through the levee, 1 foot below the crown. Pile structure in the stream. Damaged siphon breaker at the landside (LS) toe. (Plans for installation of three pumping plants on the north levee of French Camp Slough authorized under Permit No. 3340-A, 1960 - City of Stockton).

WS- abandoned pump station.

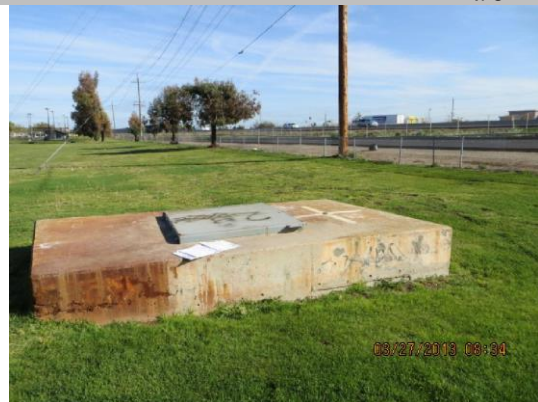
Photo 1 of 3 : UCIP\_SP\_2018\_10846\_18127.jpg

LM Start	1.76	Rating **	M	Issue No.	29
LM End	1.76	Issue Type +	En	Location *	
Category	Supplemental			GPS Latitude/Longitude	
				Start	End
Item	DWR UCIP Field Study			37.917284 °	37.917284 °
				-121.291740 °	-121.291740 °
DWR ID					
Comment Code					
Inspector Comment					
FS_ID:10846 DS_ID:18804 EP_NO: N/A Repair Type: Non-Urgent Crossing Status: Indicator Found UCIP Comments: Only a 7 ft x 14 ft concrete vault found on LS.Needs a sign post.Bob Winter from KSN(representative of RD 404) will investigate on this crossing. FIELD_STRUCT_DESC: 1 of 2: 42-inch reinforced concrete sewer line through the levee, 8 feet below the crown. Pipe crosses another 42-inch sewer line under the channel. [Additional Reference(s): DWR Levee Log, 2006]. FS Date: 3/27/2013

LS- 7' x 14' concrete vault.

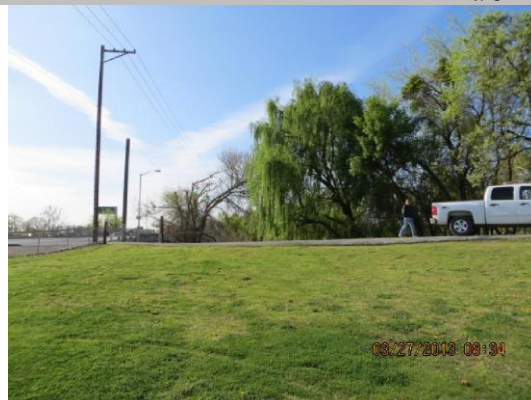
Photo 2 of 3 : UCIP\_SP\_2018\_10846\_18126.jpg

Crown view of the levee.

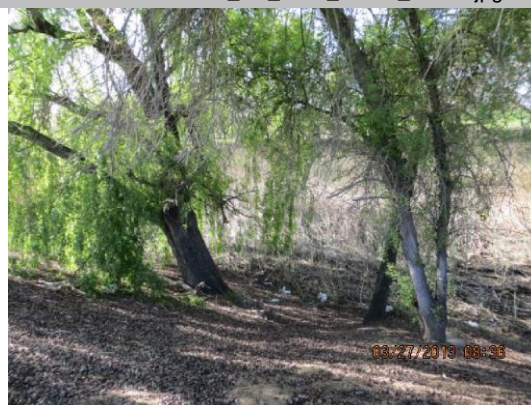
Photo 3 of 3 : UCIP\_SP\_2018\_10846\_18128.jpg

WS- no pipes found.

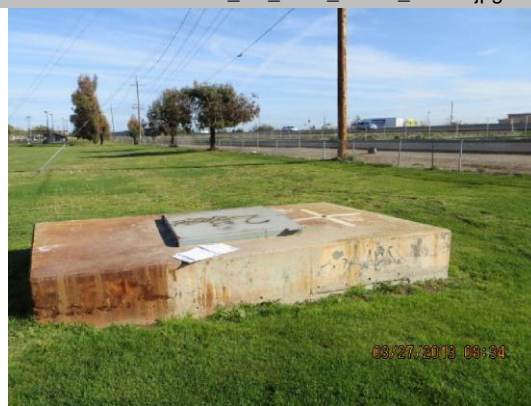
Photo 1 of 3 : UCIP\_SP\_2018\_12426\_20130.jpg

LM Start	1.76	Rating **	M	Issue No.	30	
LM End	1.76	Issue Type +	En	Location *		
Category	Supplemental			GPS Latitude/Longitude		
				Start	End	
Item	DWR UCIP Field Study			37.917284 °	37.917284 °	
				-121.291740 °	-121.291740 °	
DWR ID						
Comment Code						
Inspector Comment						
FS_ID:12426						
DS_ID:18787						
EP_NO: N/A						
Repair Type: Non-Urgent						
Crossing Status: Indicator Found						
UCIP Comments: Only a 7 ft x 14 ft concrete vault found on LS.Needs a sign post.Bob Winter from KSN(representative of RD 404) will investigate on this crossing.						
FIELD_STRUCT_DESC: 2 of 2: 42-inch reinforced concrete sewer line through the levee, 8 feet below the crown. Pipe crosses another 42-inch sewer line under the channel. [Additional Reference(s): DWR Levee Log, 2006].						
FS Date: 3/27/2013

LS- 7' x 14' concrete vault.

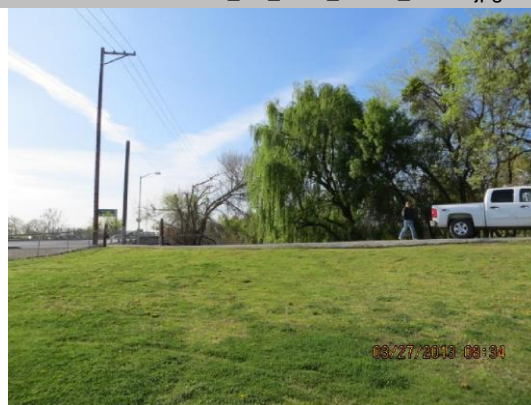
Photo 2 of 3 : UCIP\_SP\_2018\_12426\_20129.jpg

Crown view of the levee.
